Quality Assurance and Data Management for the Inclusion of Residual Stresses

A-10 ASIP, USAF

13 Sept 2018

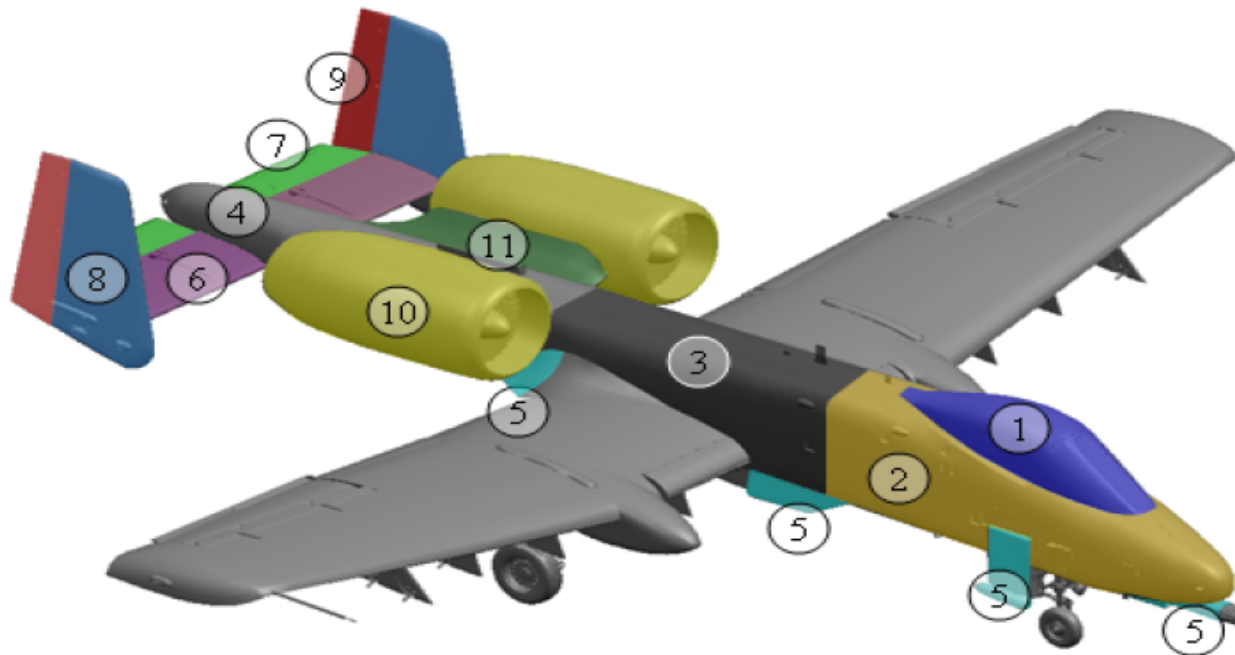
- 3D MBD(Legacy & EWA)
 - Data managed under part number effectivity
 - Defined critical inspection locations for data management

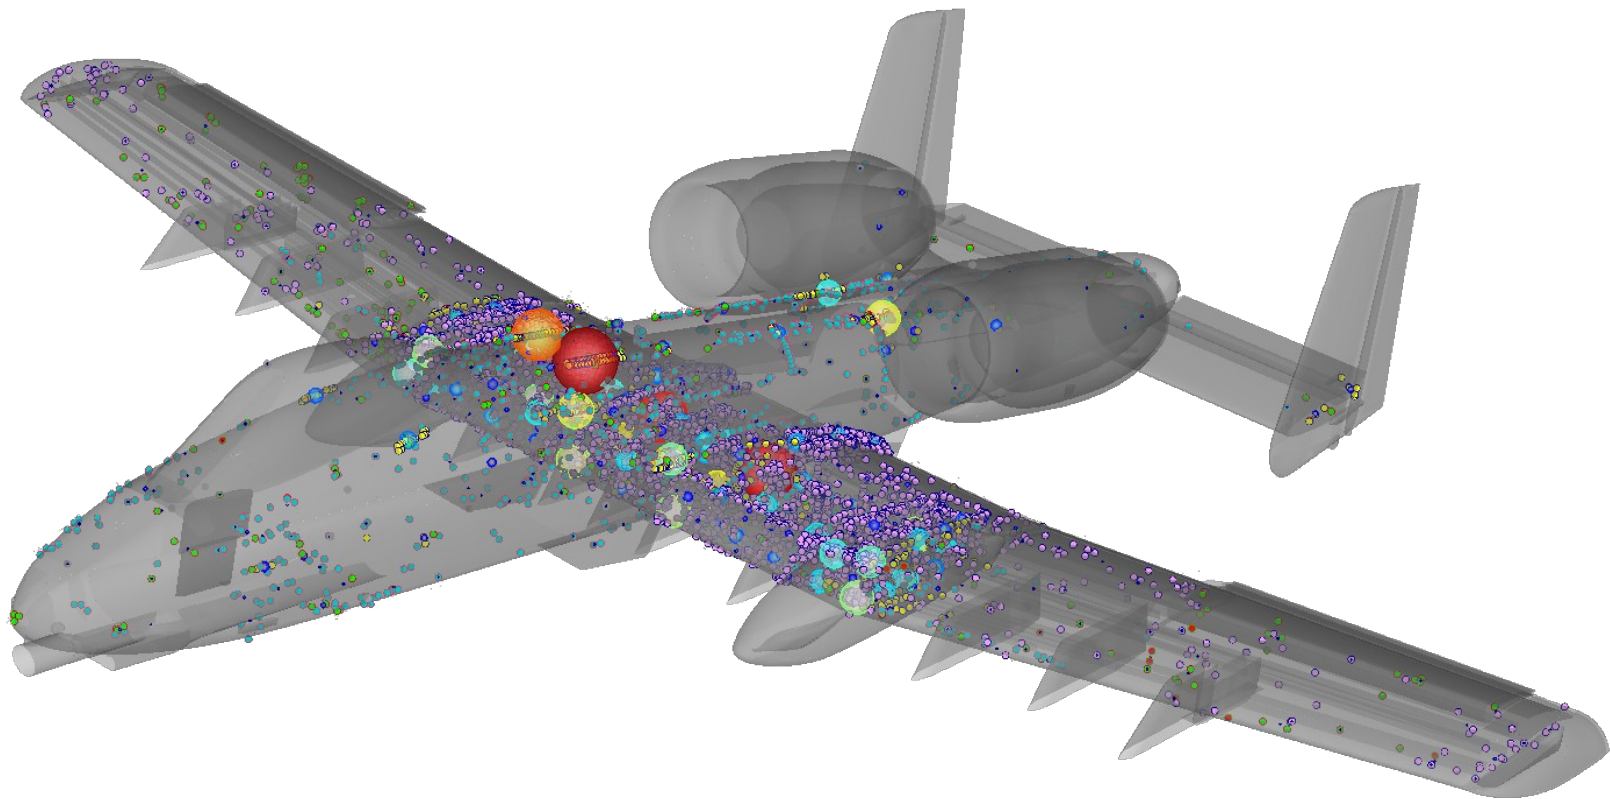
- Visual information communication

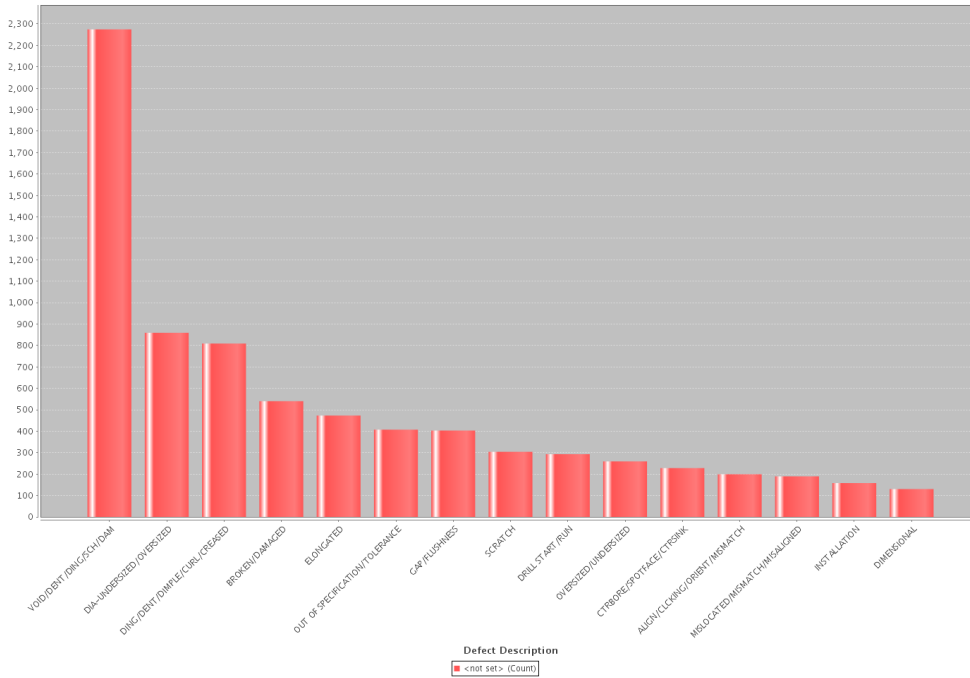
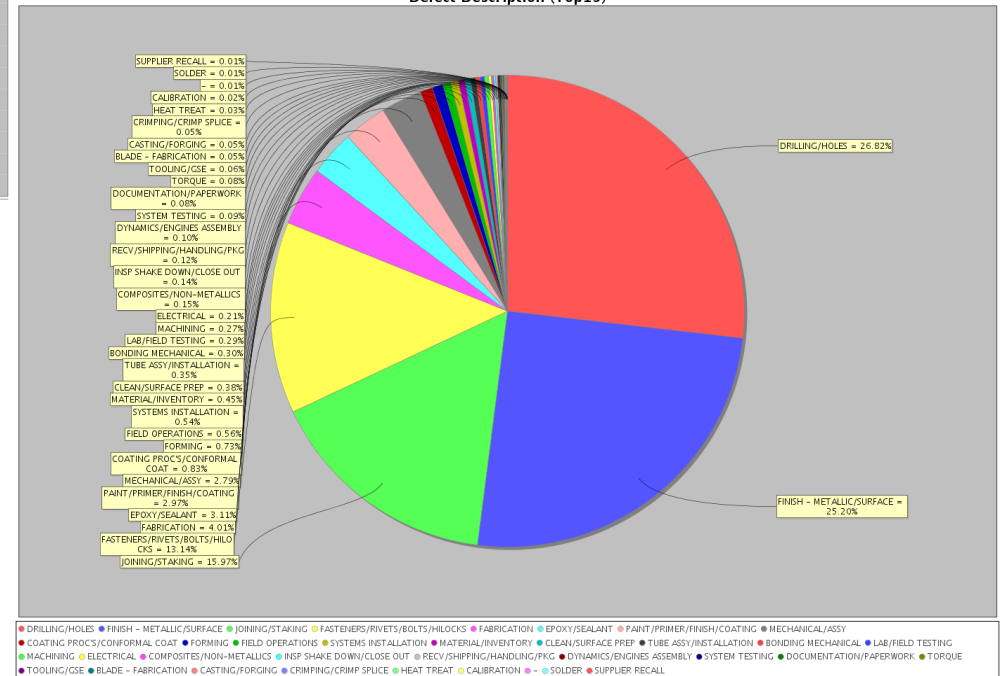
Defect Description (Top15)

Live charts to quickly communicate data and feed analysis

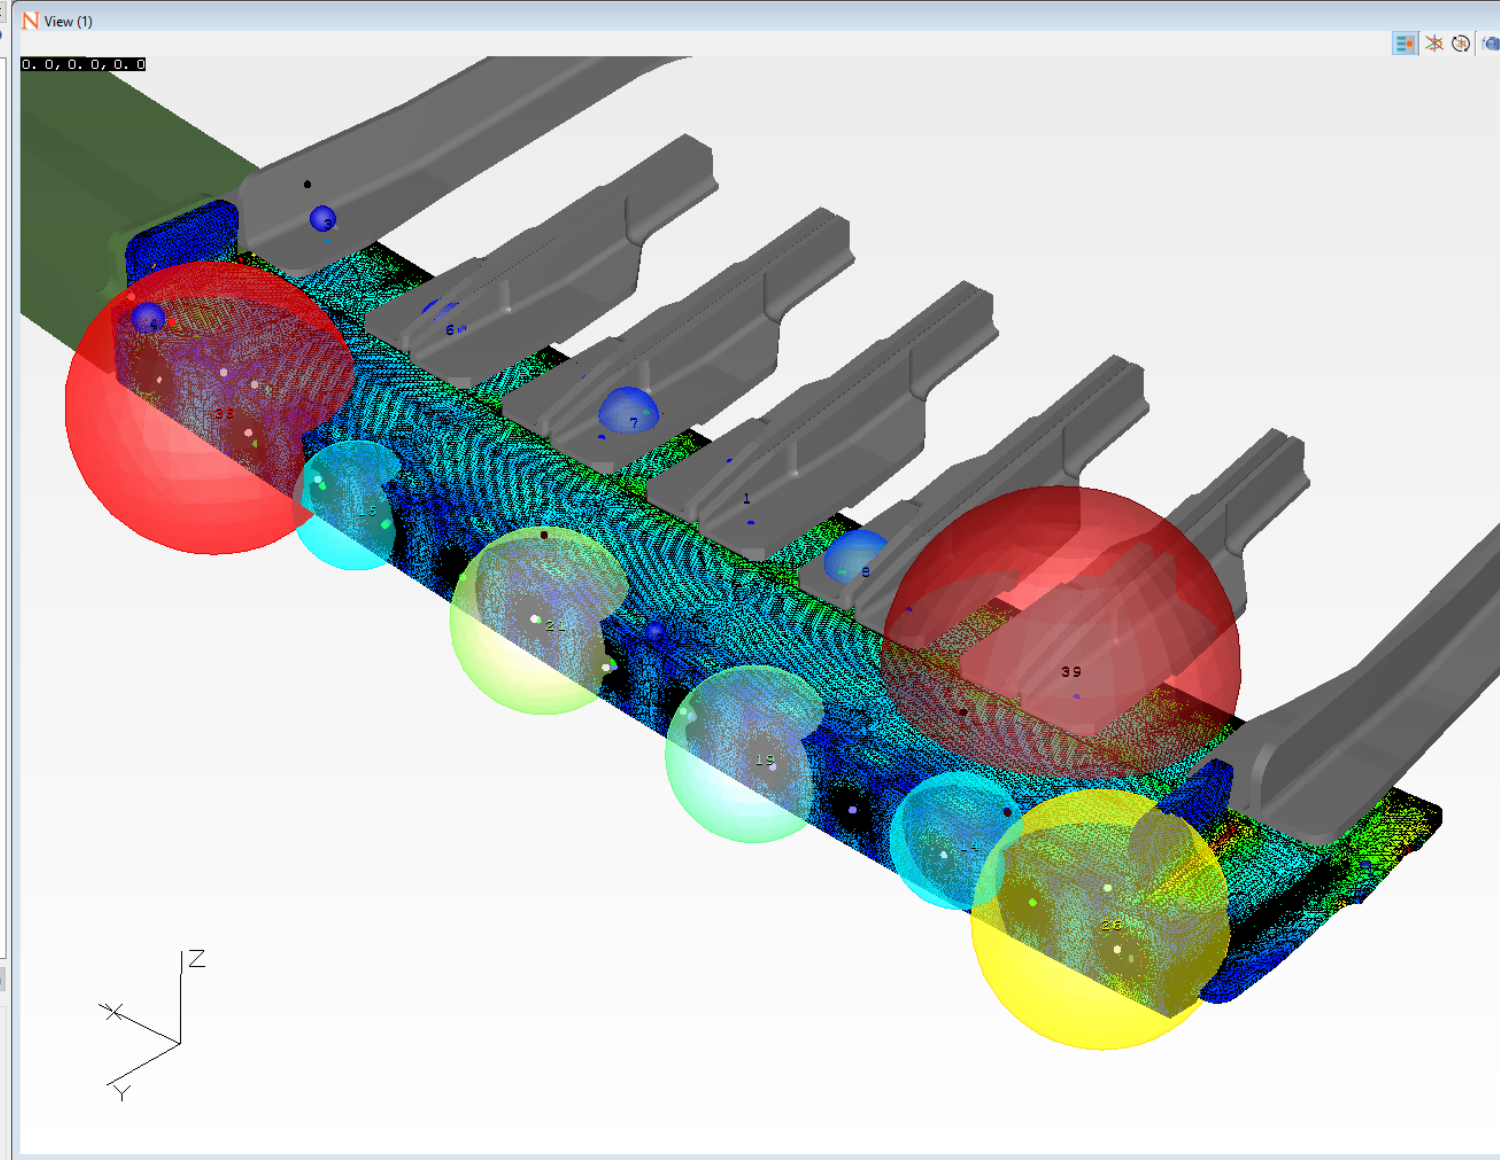
Clusters
Algorithm: Point Radius Search

Count	X	Y	Z
39	415.187	-114.86	69.063
35	433.45	-110.067	69.499
26	410.393	-110.102	68.234
21	423.858	-110.047	68.511
19	418.433	-110.072	67.941
15	429.151	-110.048	68.936
14	413.543	-110.059	68.375
8	419.979	-114.698	69.29
7	426.617	-115.123	69.857
6	431.518	-114.702	70.379
4	435.446	-110.13	70.809
3	435.766	-115.166	71.216
2	421.211	-110.351	69.245
1	423.271	-114.866	69.539
1	407.828	-114.19	68.477

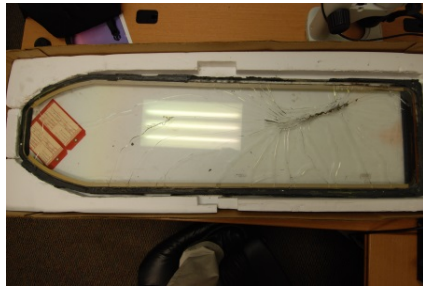
Photo of Damage

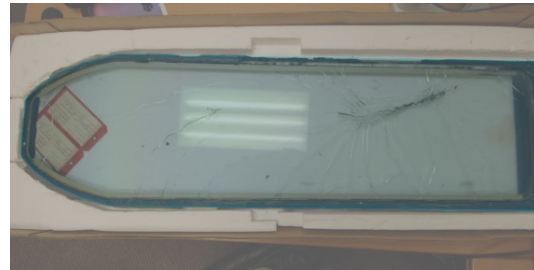
Photo alignment to Model

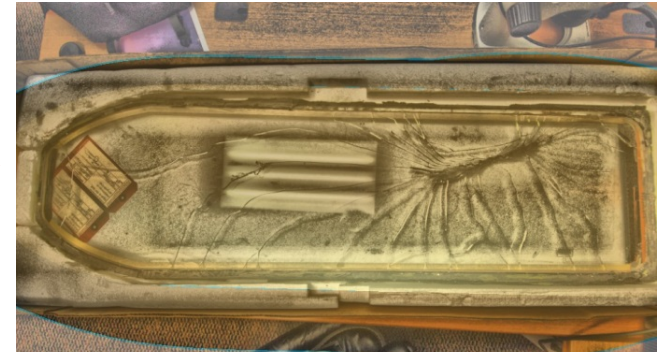
Photo Enhancements to amplify damaged regions

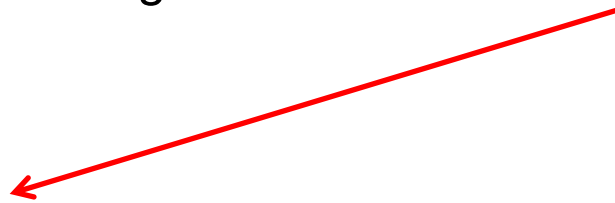
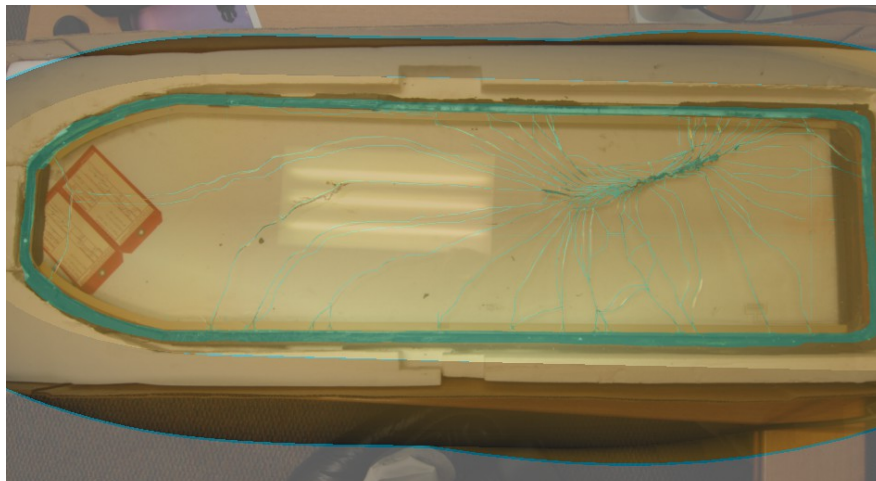
Damaged Mapped on Model for Trending

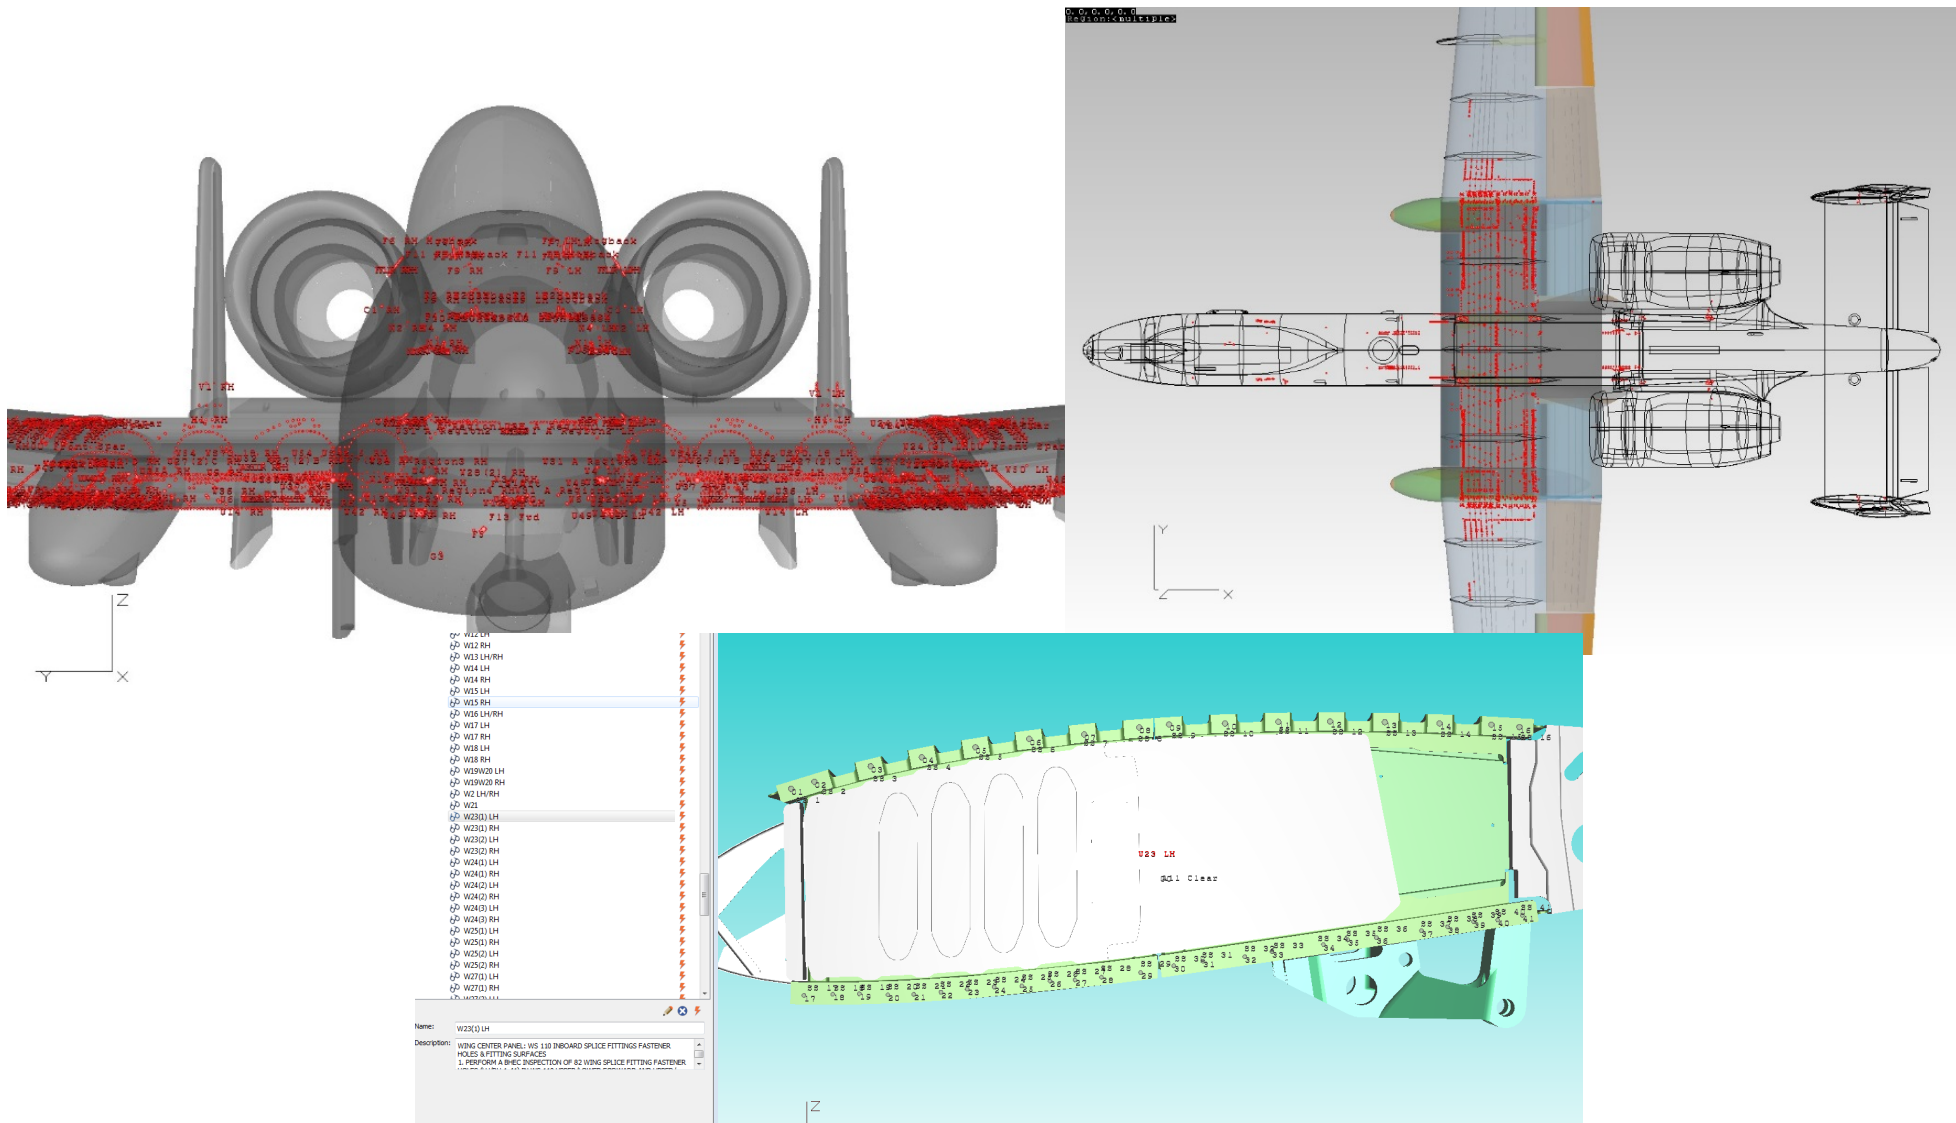
3D framework for quick and accurate digital inspection input

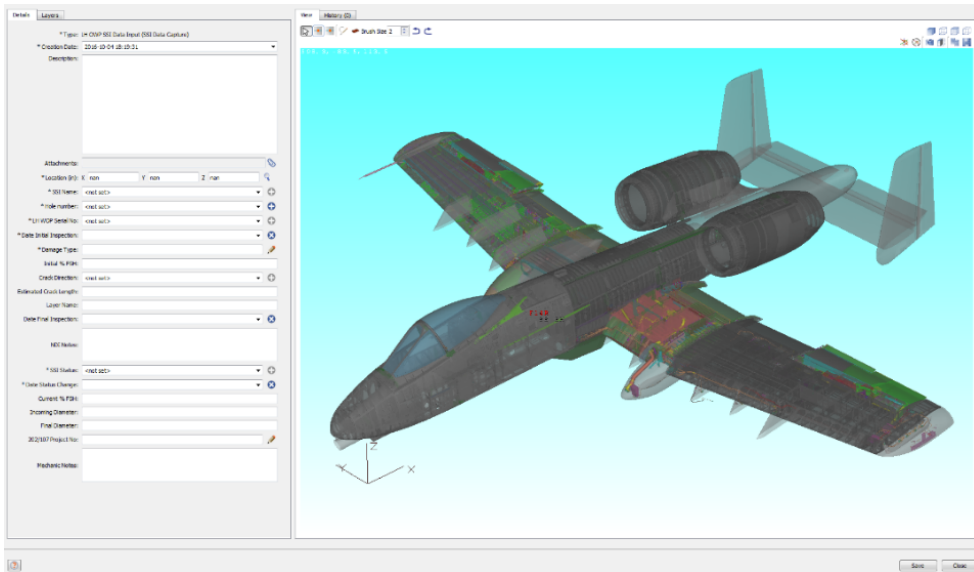
Data input screen

- Aug-Sept 2016 NLogn data collection test.
- Customized NLogn data capture trendable per SN component type
- Developed quick 'at a glance' reporting tool
 - Keep supervisors informed
 - Keep NDI tech and Mechanic in sync to work remaining

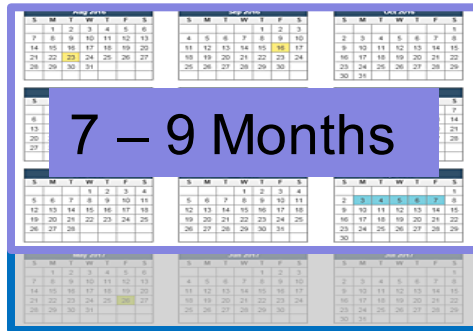
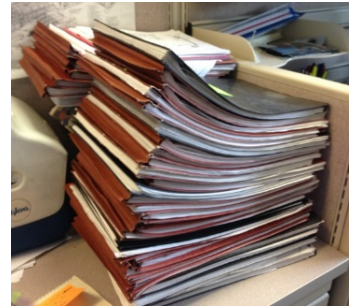
Historic SSI Data Capture Process

Low Quality

- OWP 2016 test:
 - 3 weeks to complete with 100% data accuracy
 - Data available to engineers ~ 800% faster
- CWP 2017 = 2.5 months to complete with 100% data accuracy
 - Data available to engineers ~ 500% faster
- 2018 full implementation of NLign on shop floor.
